TECHNICAL REPORT ARLCD-TR-85003

**INVESTIGATION OF DAMAGED LANDS OF M185 CANNON
MOUNTED ON THE 155-MM M109A1 HOWITZER**

JUNE 1985

U.S. ARMY ARMAMENT RESEARCH AND DEVELOPMENT CENTER

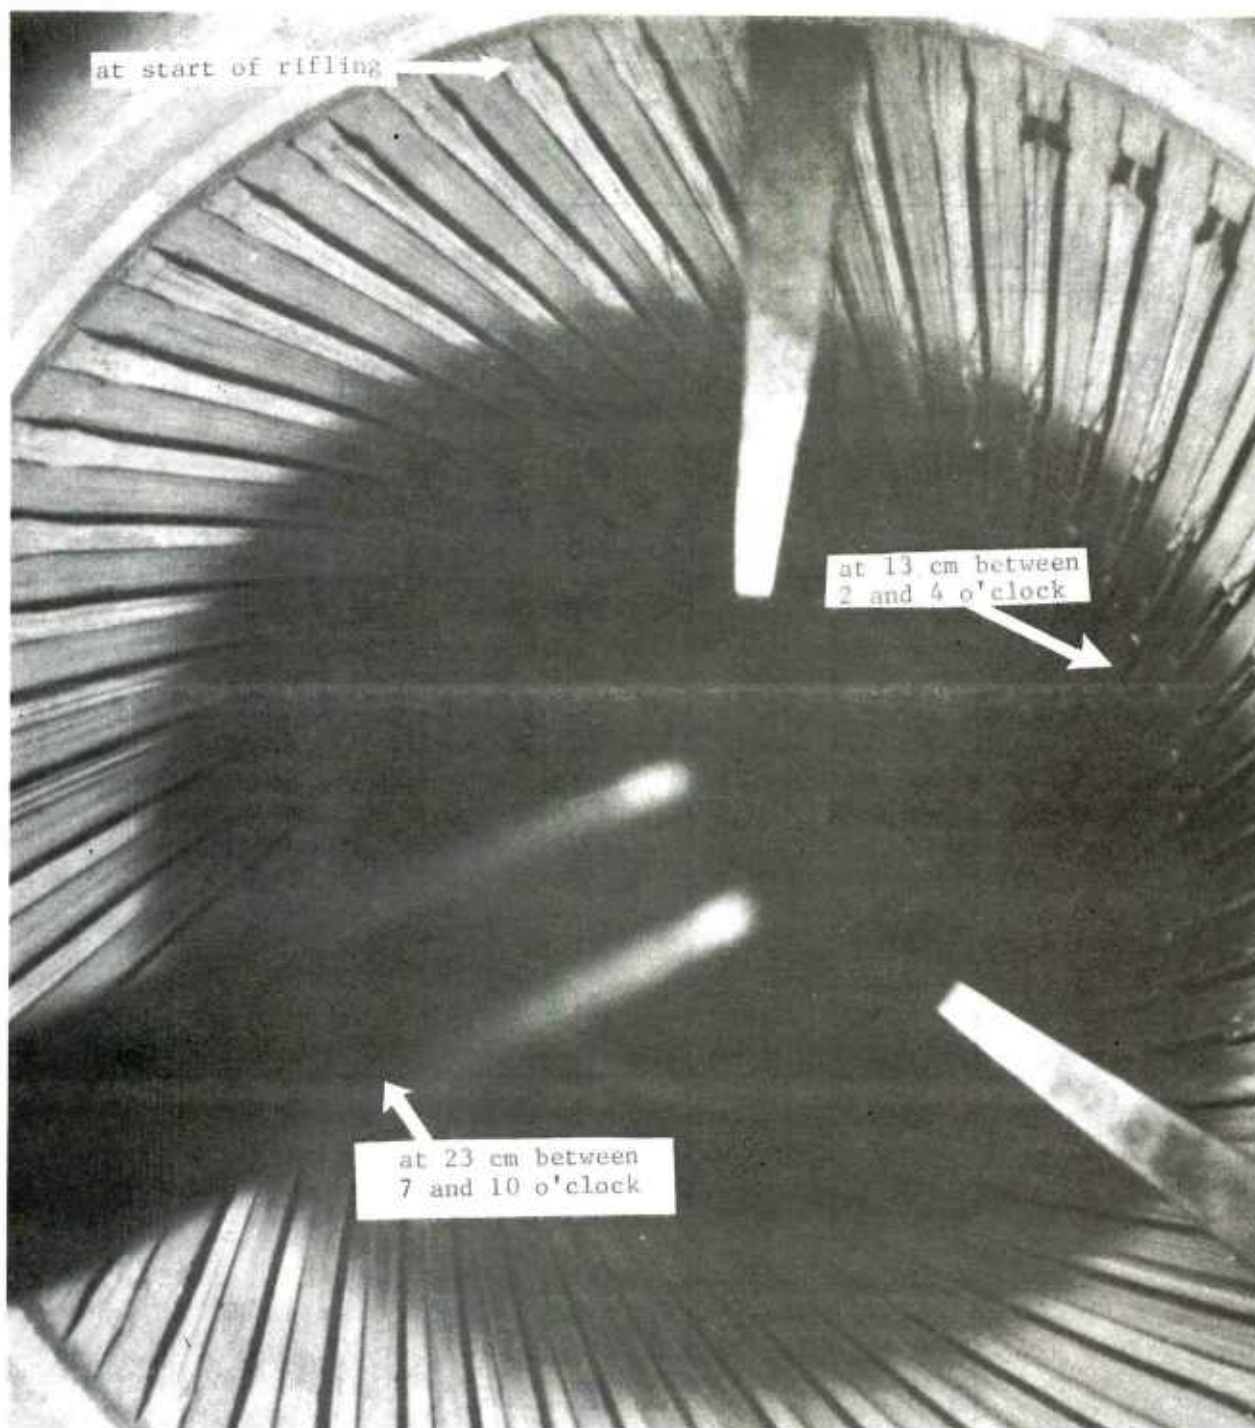
Figure 4. Damage to tube S/N 25460

A list of the tubes reported as damaged as of October 1981 is provided in table 1. Photos depicting damage representative of the kind reported by the Netherlands are contained in figure 4. (Tube S/N 25460 was condemned.) In general, criteria for tube condemnation are based on accuracy loss of the weapon. Sudden erratic deviations from the probable error of velocity, range, and deflection can be associated with a considerable loss of propellant energy (as would be found from firing an unseated projectile) or a stripped or sheared rotating band (i.e., the removal of the entire rotating band, or of the engraved portion of the band so that the band surface is smooth). Loss of propellant energy is termed blowby and, when it occurs with a seated projectile, it is the result of poor obturation of the rotating band. When damage occurs at or near the commencement of rifling, other deleterious effects of blowby in terms of gas wash and gas wear are enhanced. Gas wash is the smooth enlargement of the bore due to the surface metal's being gradually washed away by hot, high velocity propellant gases. Surface erosion is prevalent at the origin of rifling due to the greater gas temperatures and rotating band pressures that are found there. Gas wear, otherwise known as scoring, is attributed to the nozzle or venting action of gases escaping past the rotating band. As the nozzle area grows, so do scoring effects. These effects are more prominent at the 12 o'clock position because of the clearance found due to the weight of the projectile. The effects are usually discernible as longitudinal streaks in the bore which develop into irregular gutters and holes extending gradually over the grooves and into the non-driving side of the land (see fig. 5). Most tubes will fail ballistically, however, before deep scoring poses a serious problem in terms of gun tube strength.

a. Damage at start of rifling, at 13 cm, and at 23 cm

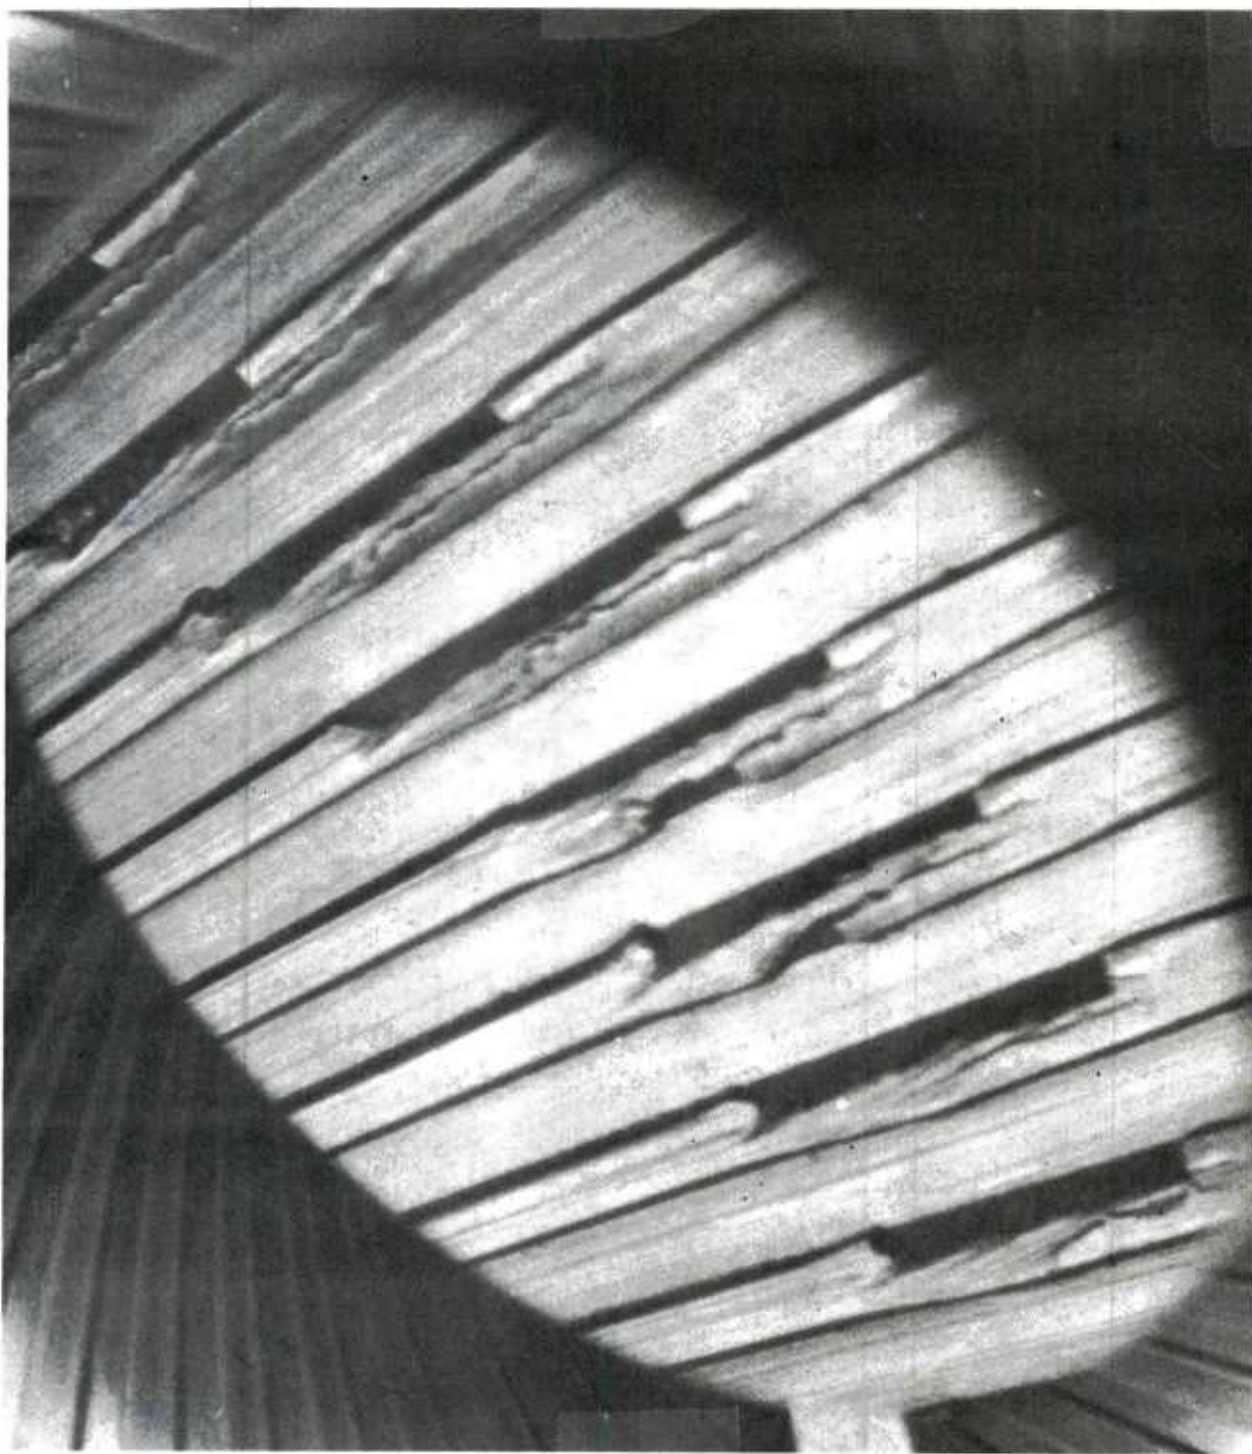
Figure 4. (cont)

b. Enlargement showing damage at 13 cm between 2 and 4 o'clock

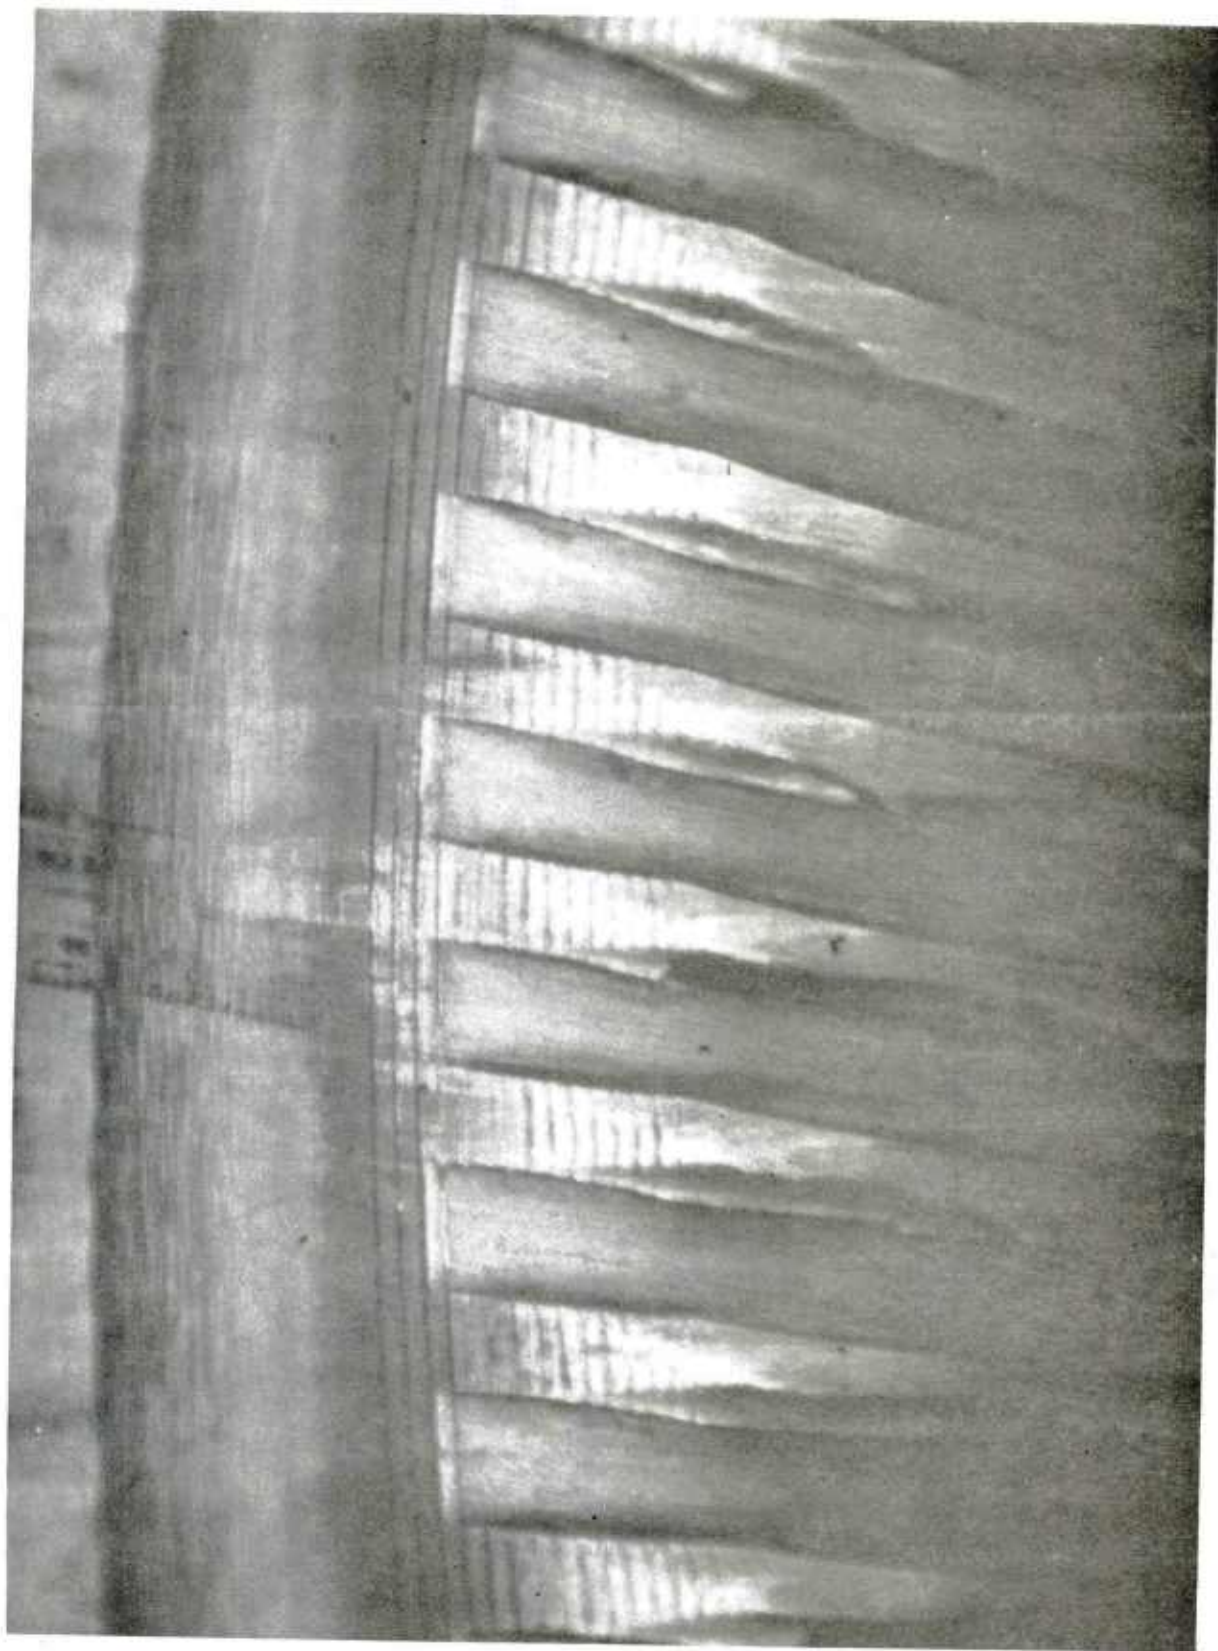
cracks in this or in any of the other projectiles. On the ninth round, photographic evidence of fuze damage was provided by smear cameras located just forward of the muzzle (fig. 11). In addition, this round was earmarked by a distinct foreshortening of the "Roman candle" effect so pronounced in the earlier fallback rounds. This suggests that the obturation in this case was both rapid and abrupt. Testing on tube S/N 24715 ended since the damage sustained was sufficient to warrant condemnation.

Figure 9. Rifling damage to tube S/N 24715 after tube round 9--12 o'clock position

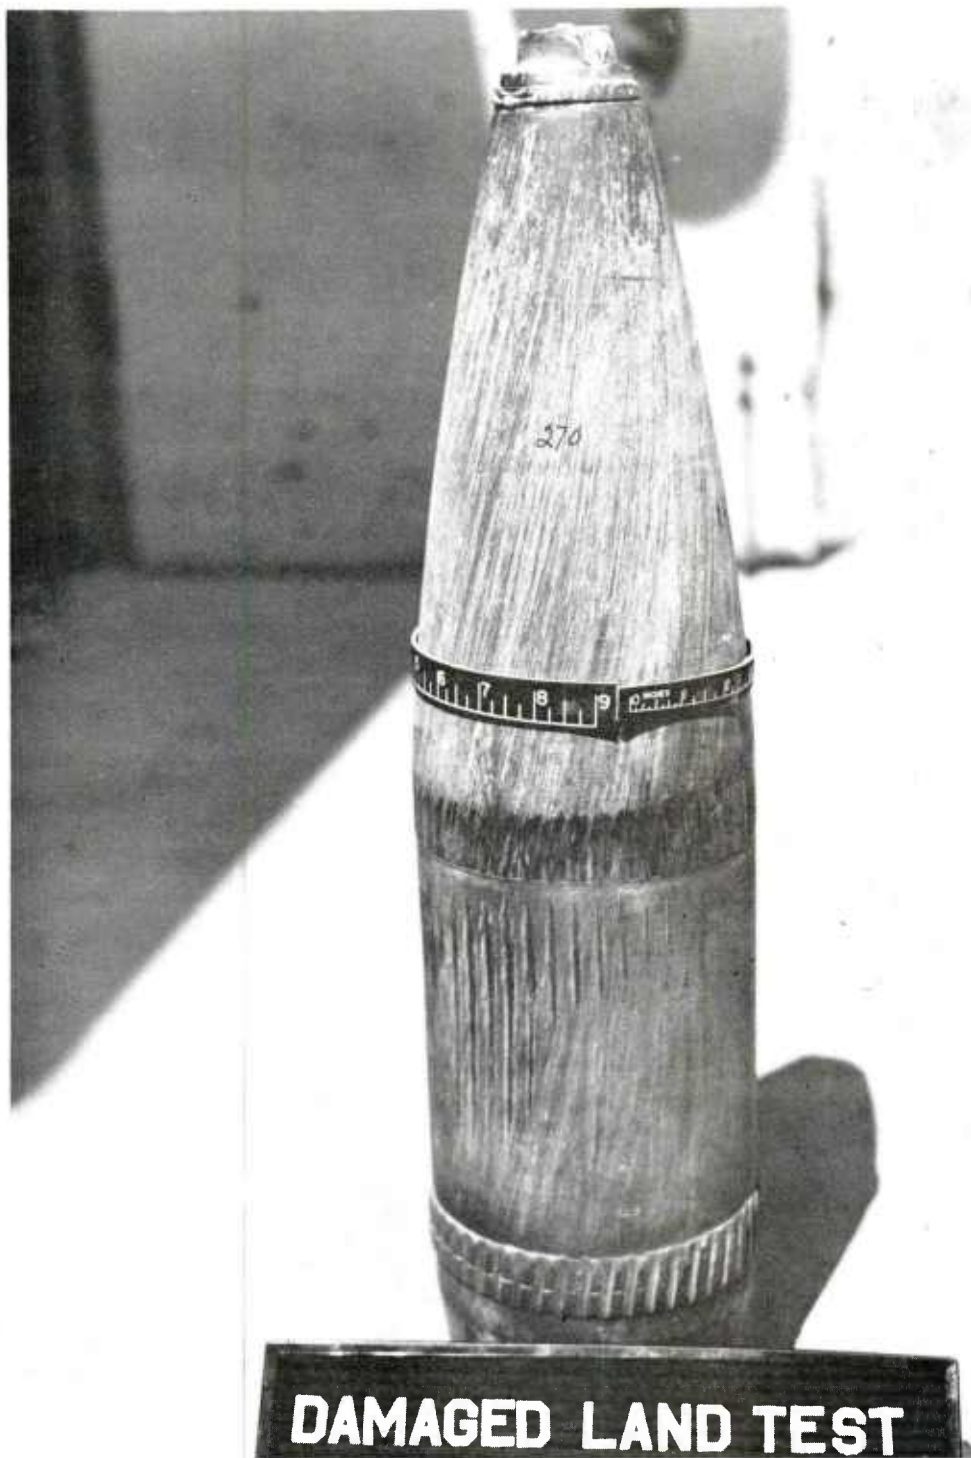
Figure 10. Recovered projectile--fallback test

a. Projectile 9 fired 1 April 1981

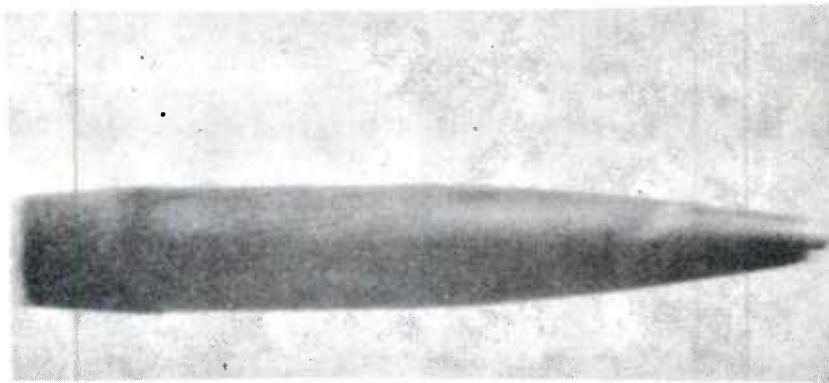
Round No. 9 fired from tube No. 24715.
Note that the windshield is missing
from the fuze. The projectile is not
proportioned properly in this photo-
graph because the muzzle velocity was
not as high as expected.

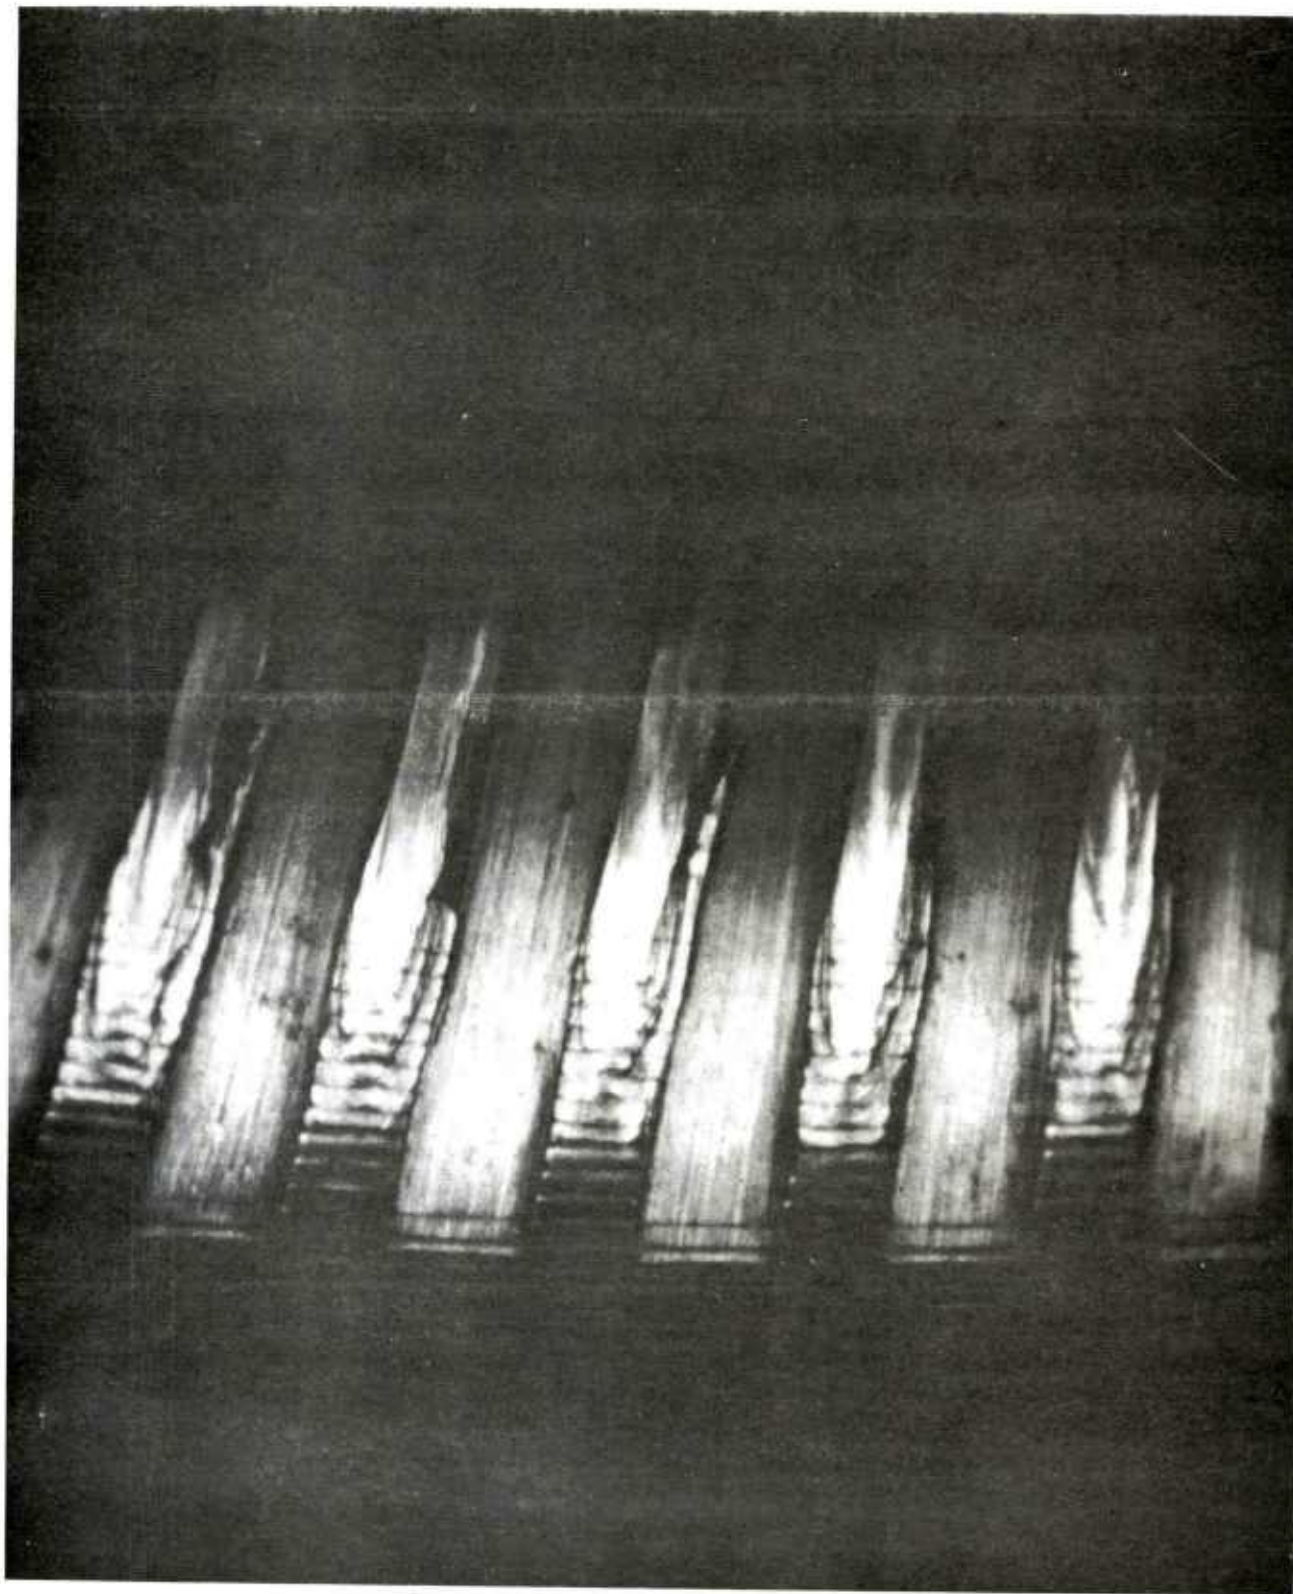
Examinations were scheduled prior to and following the test which consisted of 29 rounds. After 29 rounds, tube S/N 28317 was in a damaged but serviceable condition. A summary of smear camera observations is given in table 5 and sample photos comprise figure 13. Instability in projectile flight patterns was observed in 11 cases; fuze damage, in 4 cases. The instability was not predictive, that is, not associated with any charge/zone parameter. And, even though fuze damage occurred only with the M4A2 zone 4 charge, the sample size is too small to draw a definitive conclusion as to whether this correlation is unique and exclusive. A summary of the inspection conducted on the recovered projectiles is given in table 6. The type of projectile damage produced in firings from tube S/N 28317 is shown in figure 14. This should be compared with photos of round 9 from tube S/N 24715 (fig 10a). It is interesting to note that rounds 1, 2, 4, and 5 had distinctive engraving marks on the bourrelet whereas S/N 24715 exhibited no associative damage whatsoever.

Figure 12. Tube S/N 28317 at end of fallback test--3 o'clock position

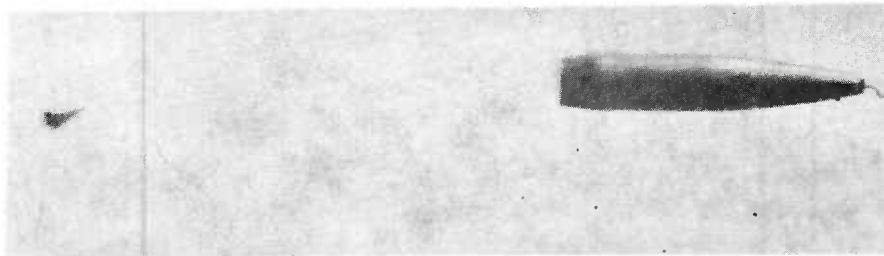
Round No. 26 fired from
tube No. 28317. Note
that the windshield is
missing from the fuze
and is behind the pro-
jectile when this
photograph was taken.

Figure 13. Smear camera photographs of flight instability and fuze damage

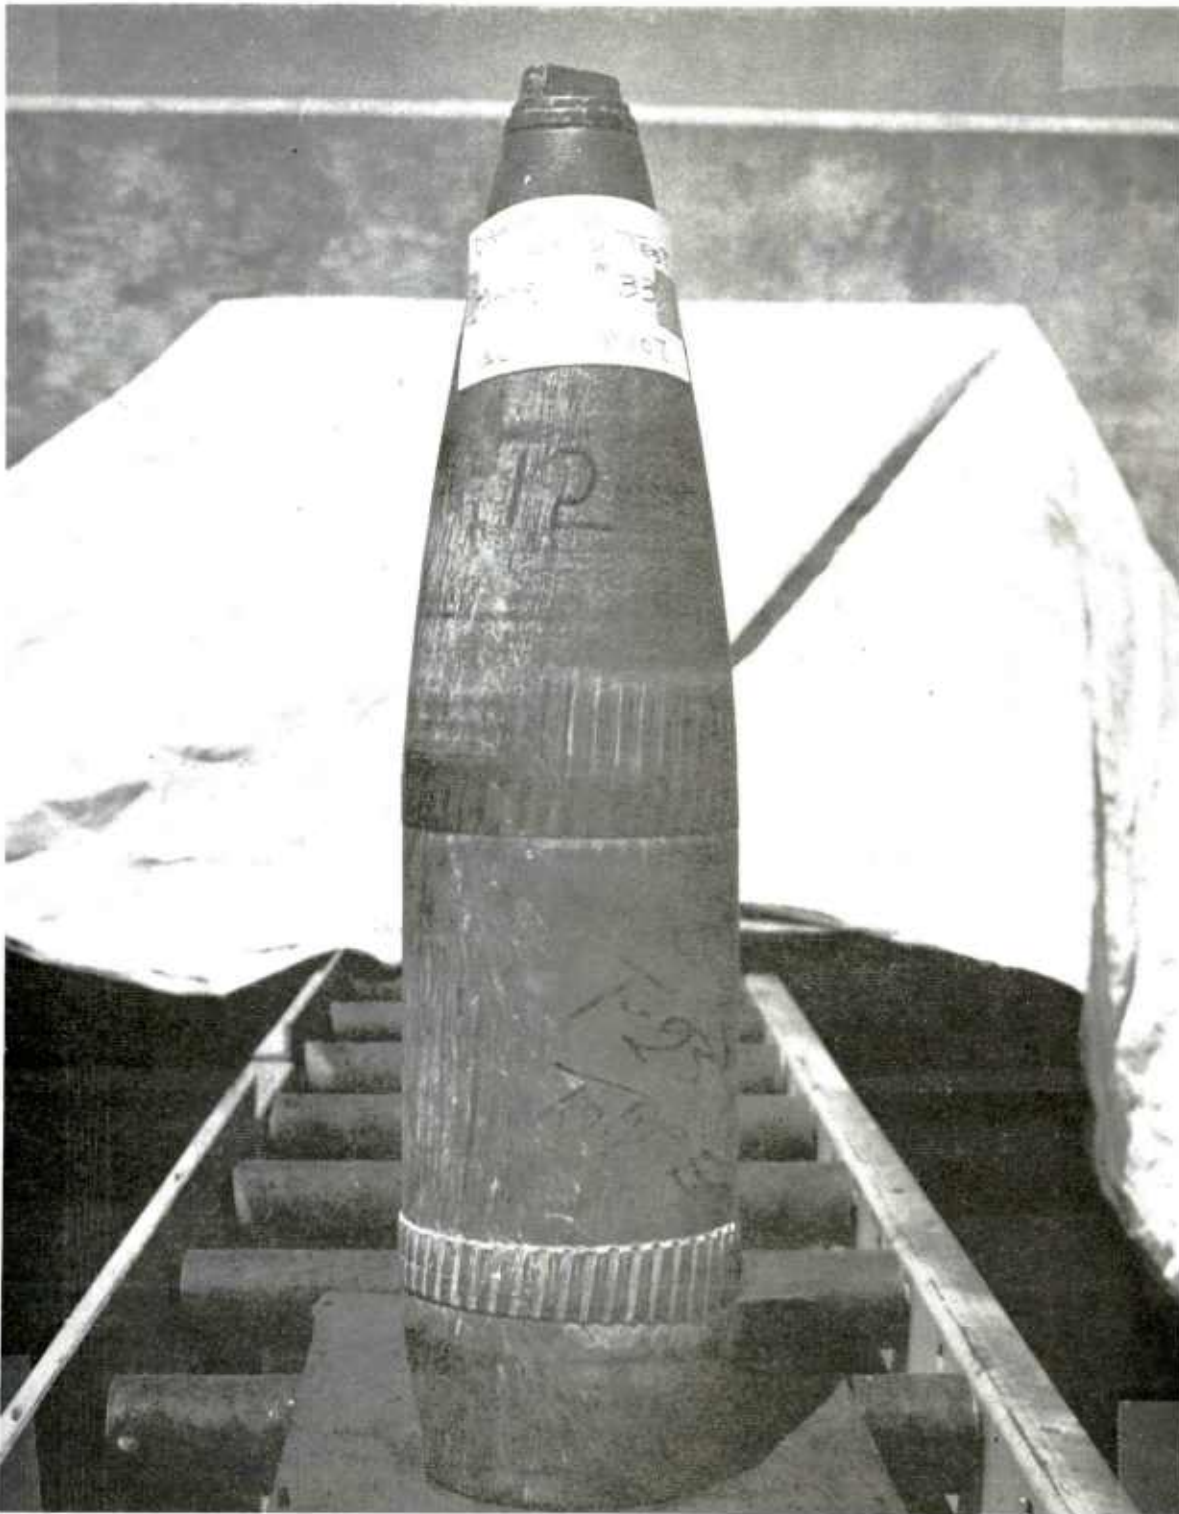
Figure 14. Tube round no. 23 fired from tube S/N 28317. Note the engraving on the ogive, front bourrelet and the body from contact with the rifling.

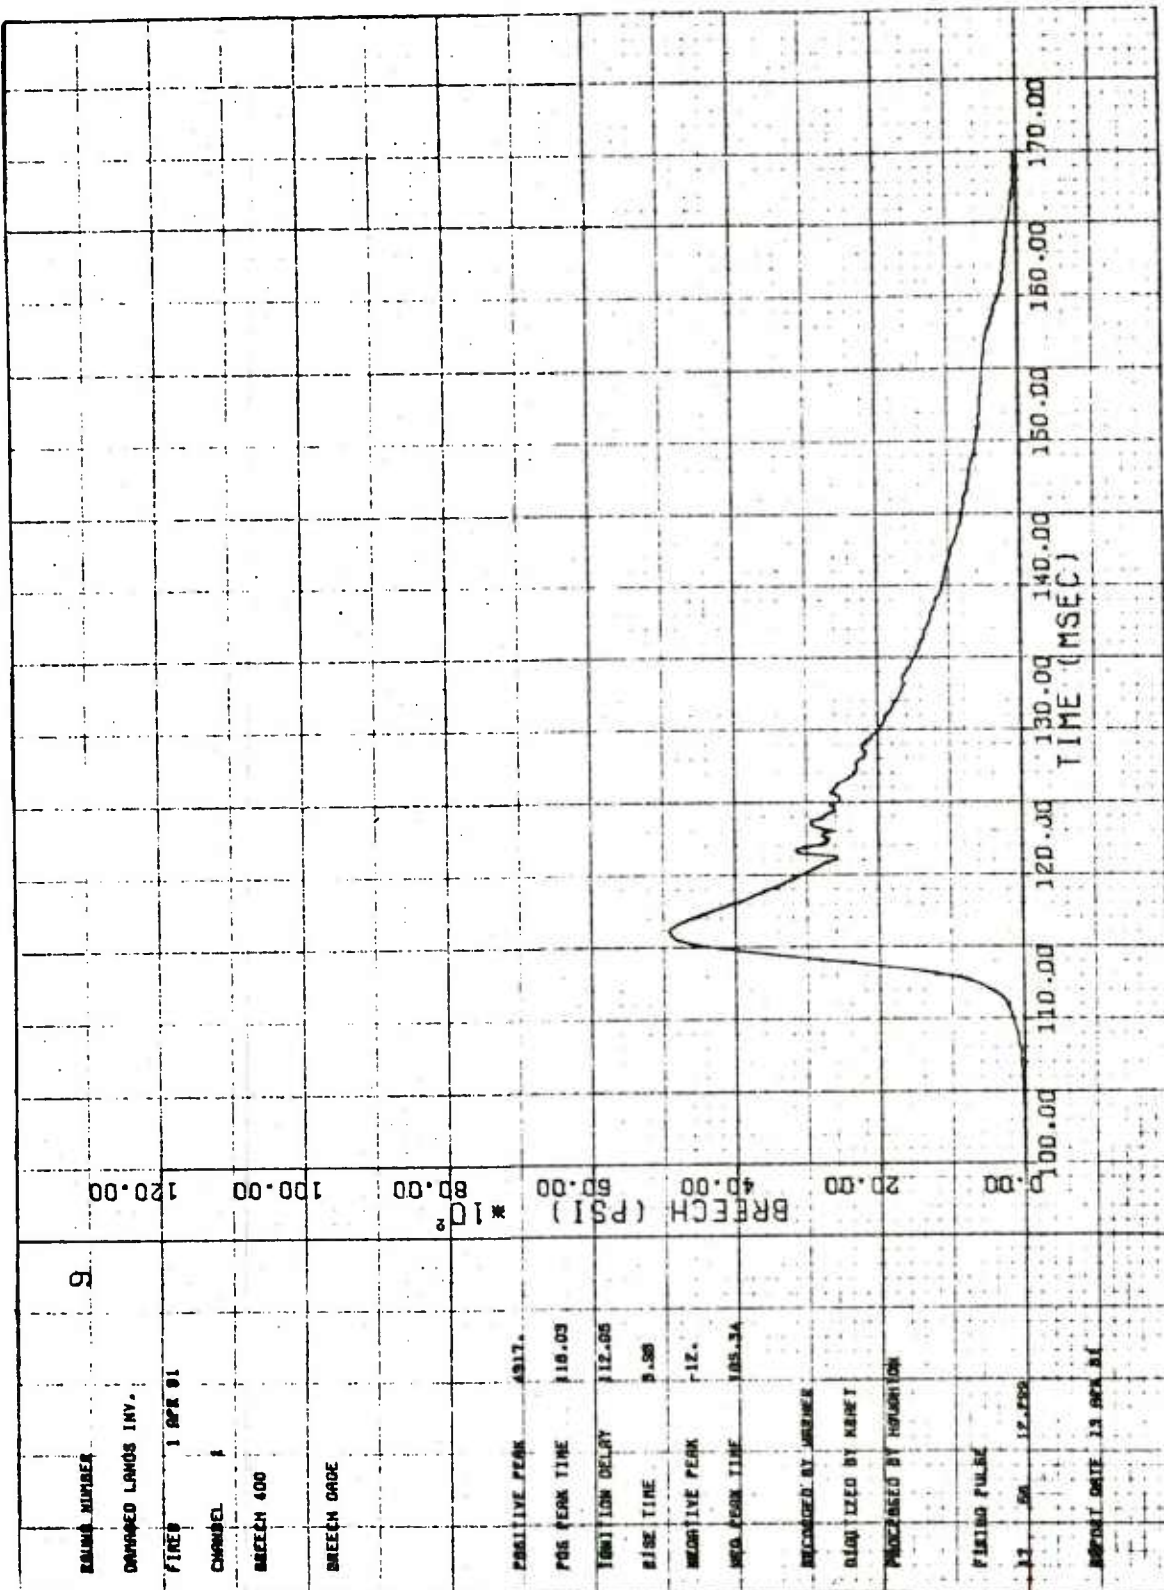
g. Breech--round 9

which was earlier termed the "Roman candle effect." The signature of a fallback round's producing damage is a choppy, erratic pressure curve as exemplified by figure 15g. This erratic behavior is coupled to a relatively short rise time, when compared to rise times of other fallback rounds; e.g., compare 26.3 msec, the average rise time for the breech pressure curve of round 9, all rounds being M107 projectiles with M4A2 zone 4 charges. Selected values from the instrumented rounds were tabulated (table 7) and pressure profiles distinguished by an abrupt, erratic signature were annotated.

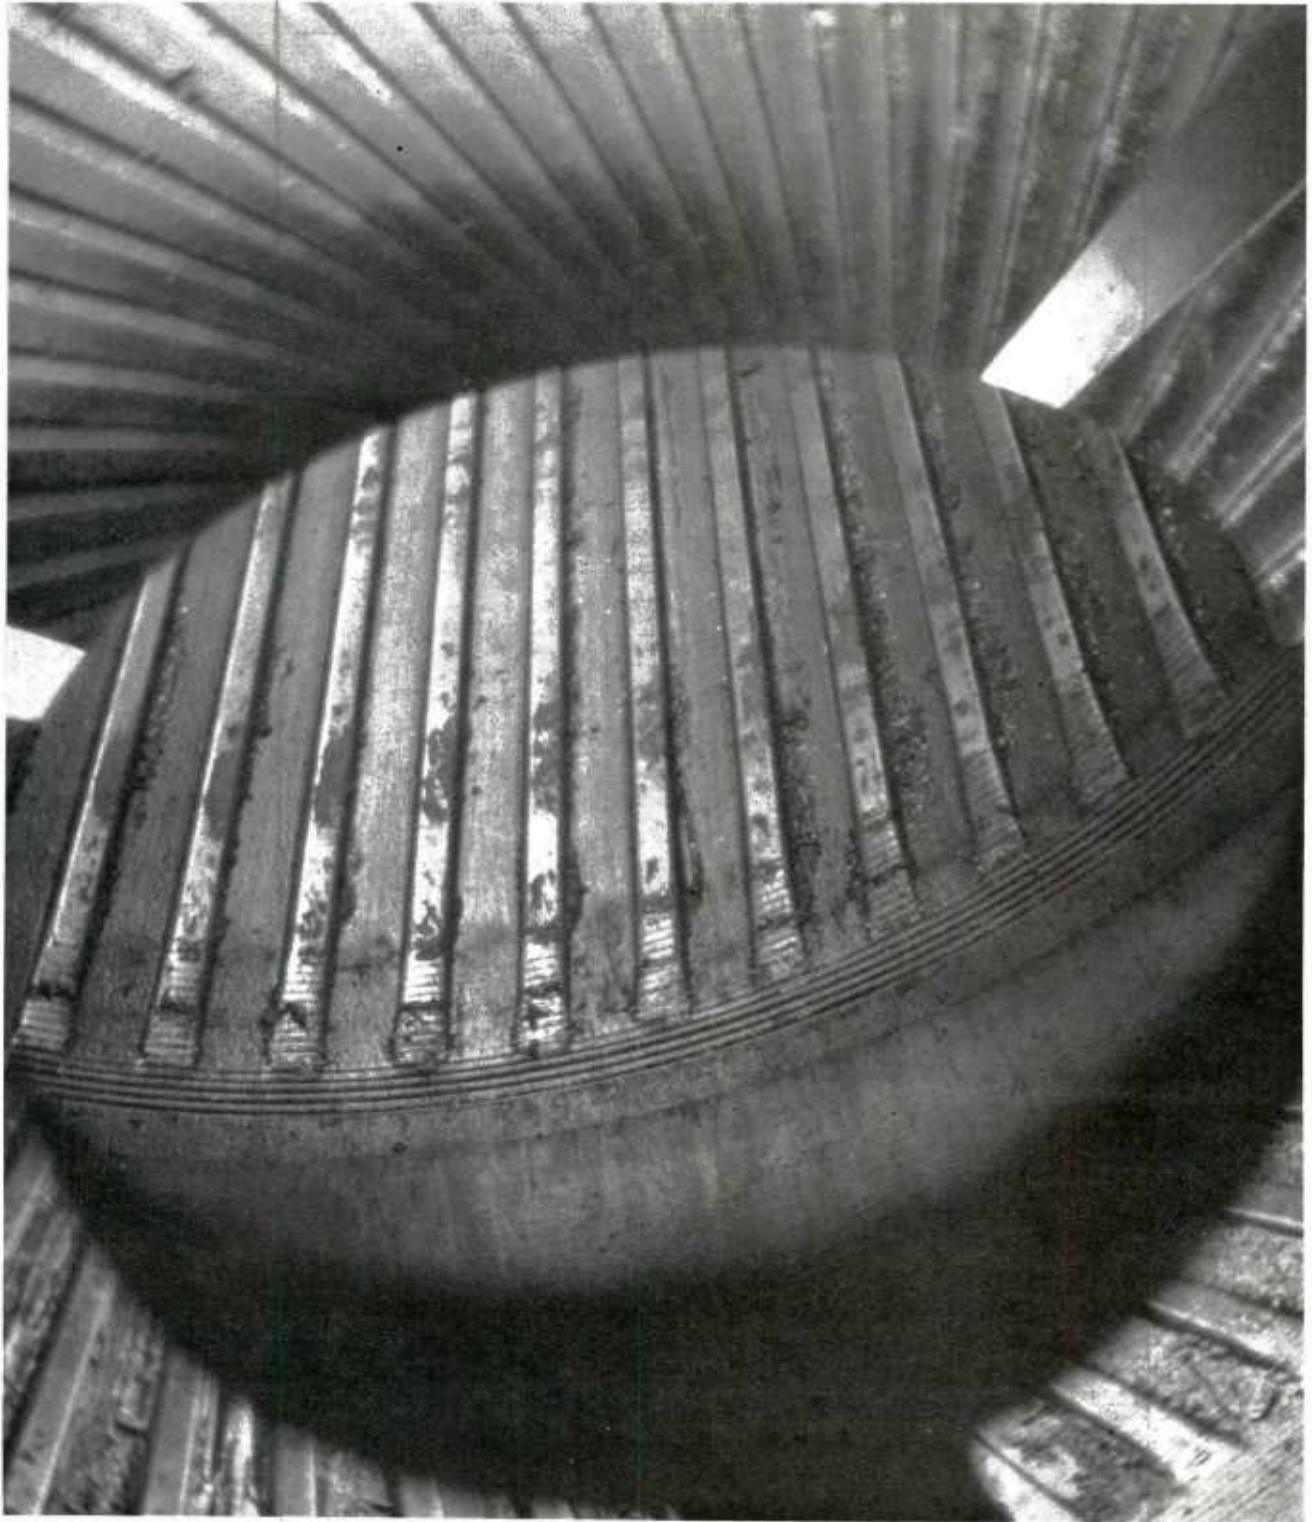
Figure 17. M185 cannon tube S/N 26066 after ramming test--shows debris but no damage

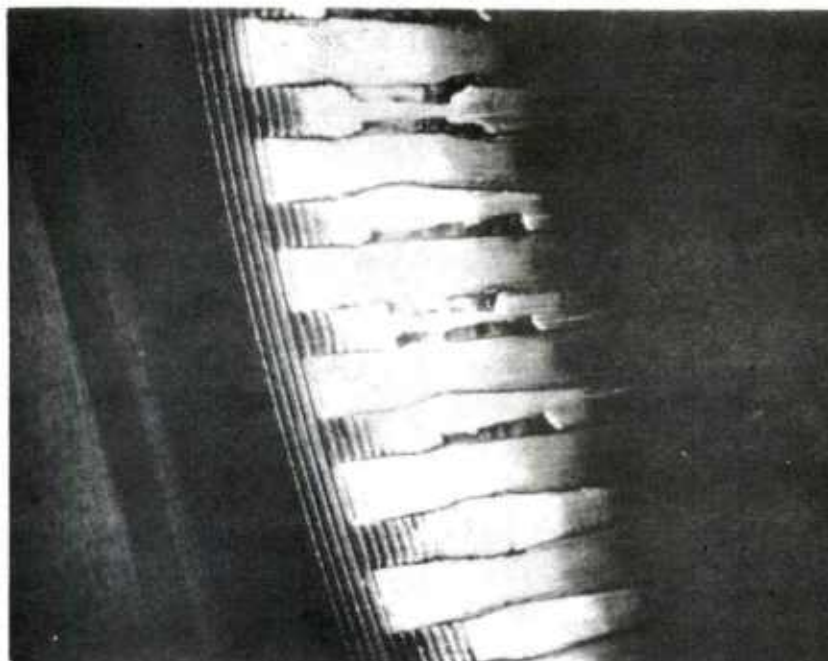
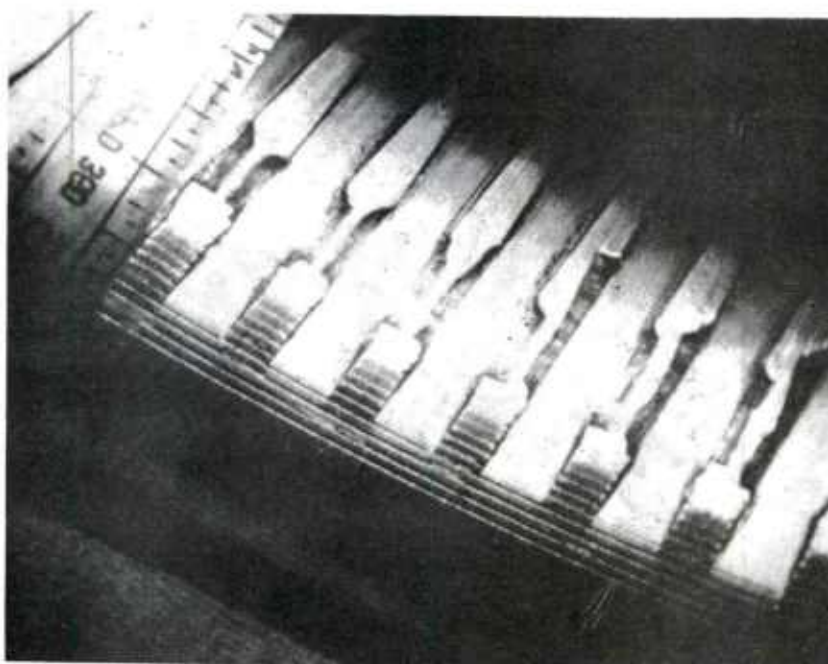
a. Origin of rifling 1 to 3 o'clock

Figure 33. 155-mm M185 howitzer tube S/N 25460 at start of degradation test after firing 458 rounds

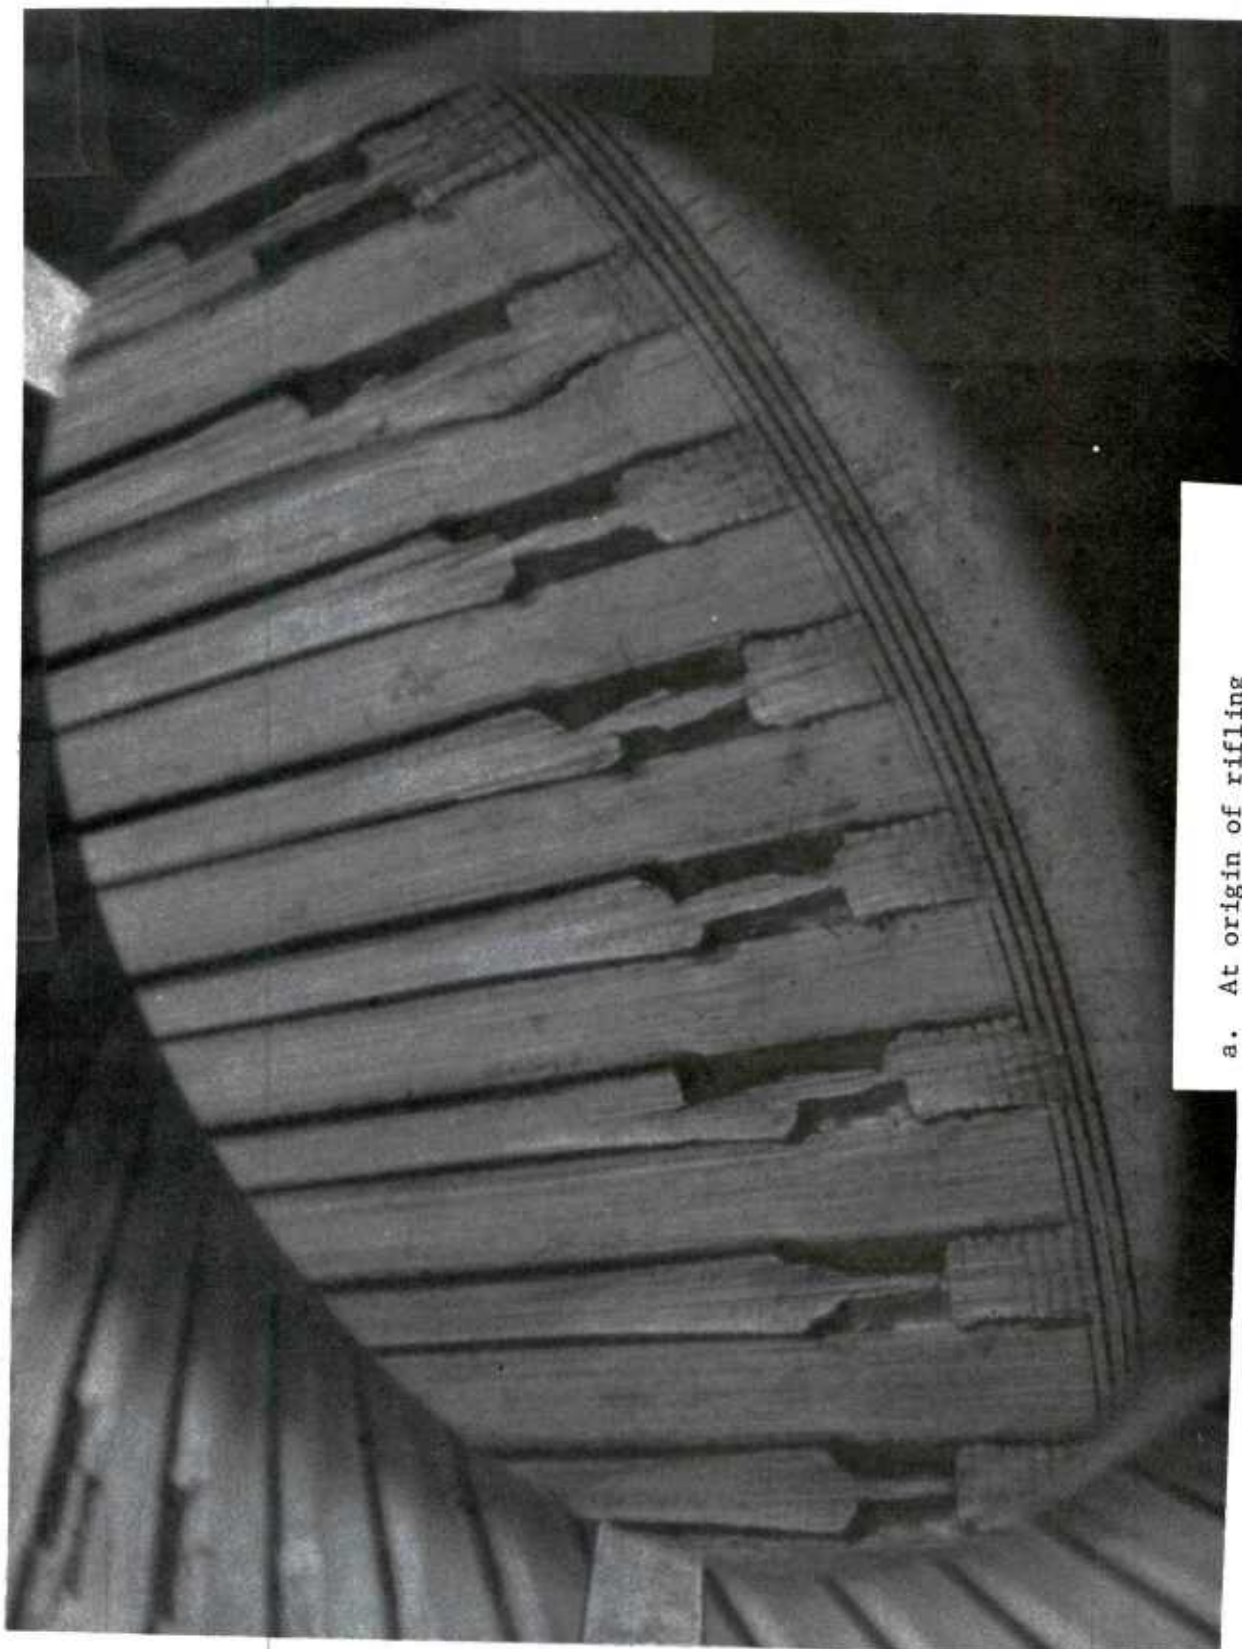
a. At origin of rifling

Figure 35. Type of rifling damage not warranting condemnation of the tube

insignificant difference in the probable error of range and deflection. No inbore forces could be identified which would compromise the safe firing of a projectile/fuze system. Consequently, a change to the criteria for tube condemnation was initiated to exclude the type of land damage reported.
